Mars Exploration Rover Mission

**Spirit
and
Opportunity**

**Month in Review
January 3, 2005 - January 31, 2005**

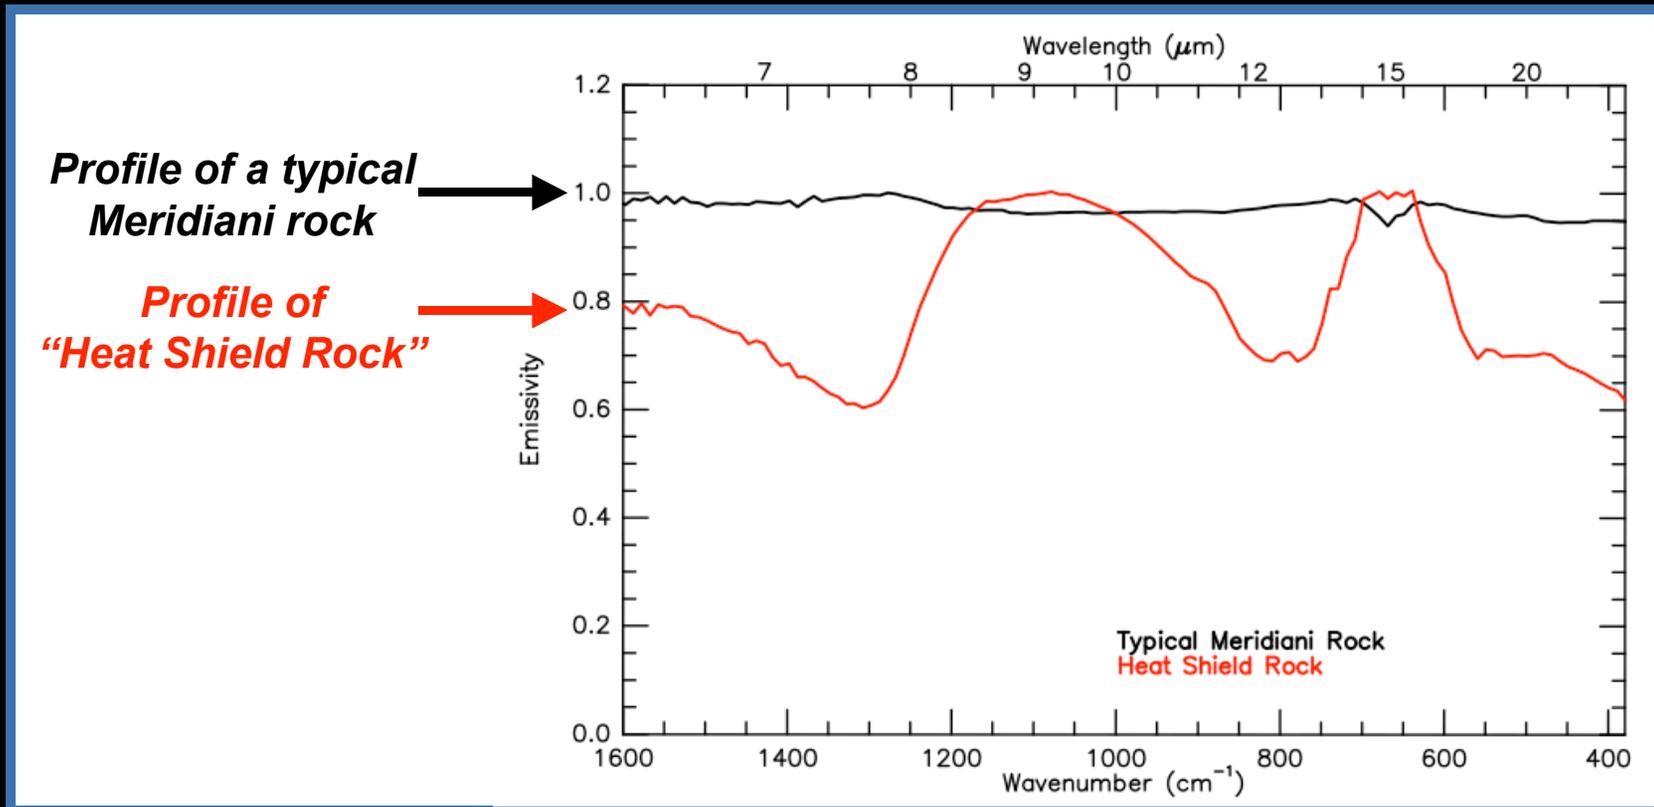
Spectral comparisons of a typical Meridiani rock and Heat Shield Rock, Miniature Thermal Emission Spectrometer. NASA/JPL

Putting on their detective hats, scientists realized that their analysis of the basketball-sized rock looked strikingly similar that of the martian sky.

When the analysis of the rock matched the sky, the team believed that the rock must be made of pure metal and was reflecting the martian sky.

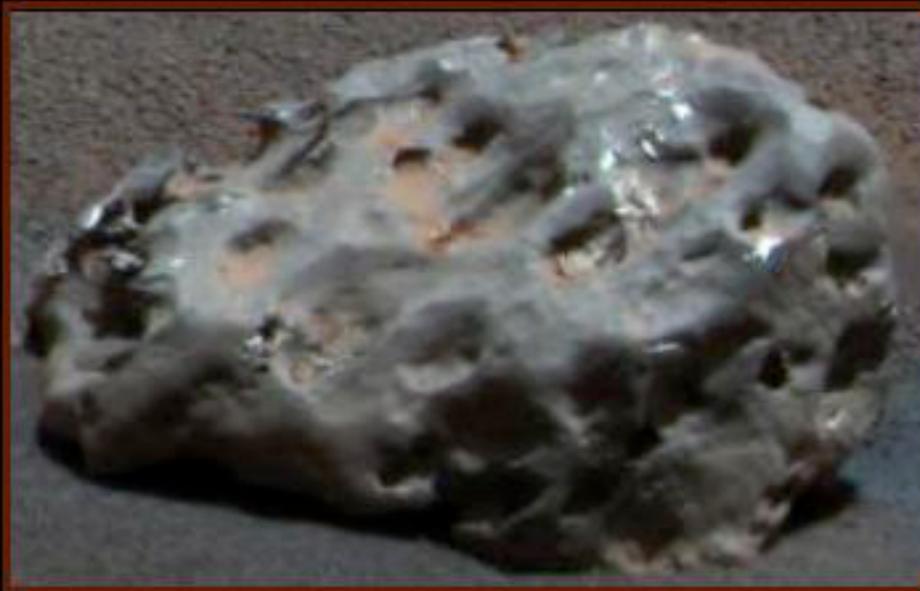
Opportunity continued to study the rock, revealing that it is composed of iron and nickel. The only rocks known to have this much metal are meteorites that come from outer space.

Approximate true-color panoramic camera image composite. NASA/JPL/Cornell

It turns out that Heat Shield Rock is a meteorite that landed on Mars!

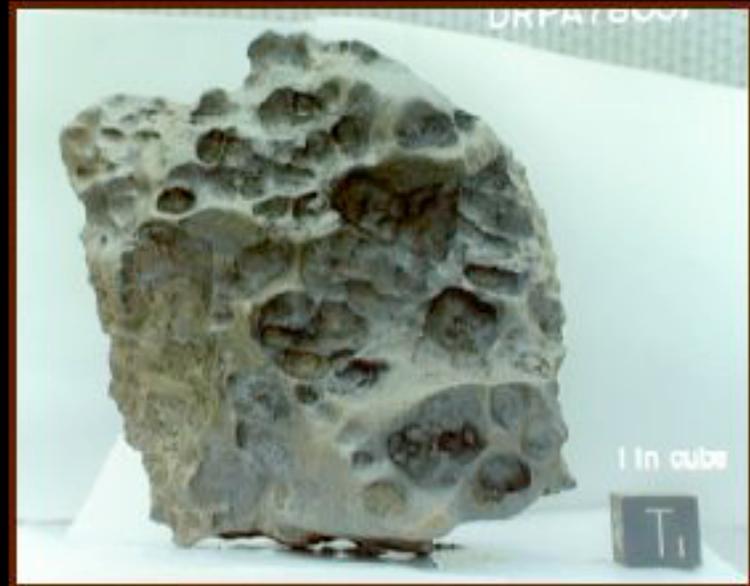
Iron meteorite found at Derrick Peak, Antarctica. NASA

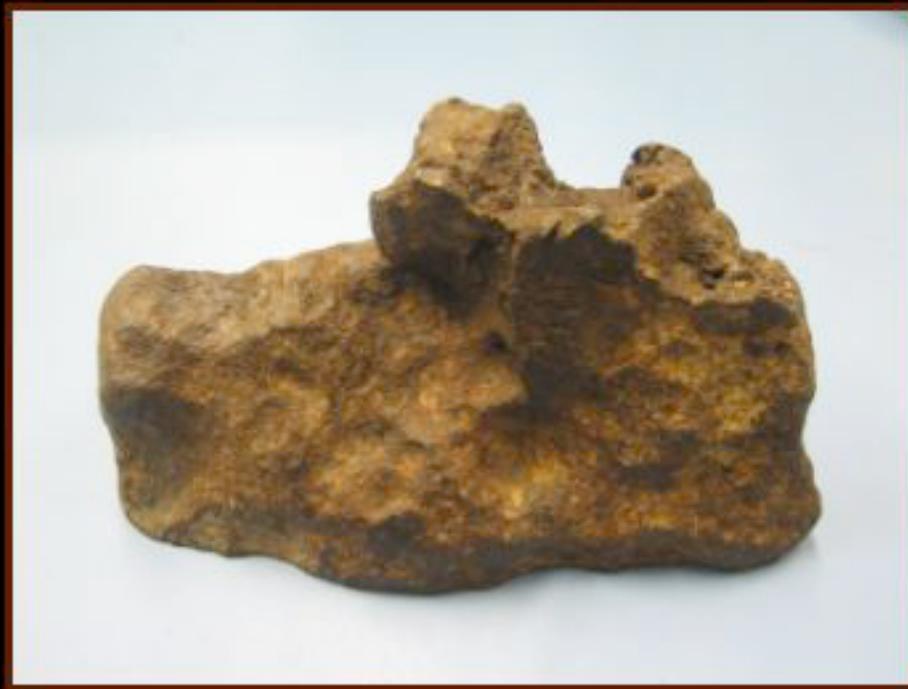
Meteorite used to test the Rock Abrasion Tool . Credit: AMNH

Using an engineering model, the team partnered with the American Museum of Natural History to test the RAT on a meteorite found on Earth.

**The museum loaned the rover team their
“Santa Rosa” meteorite, which was originally
found in Colombia in 1810.**

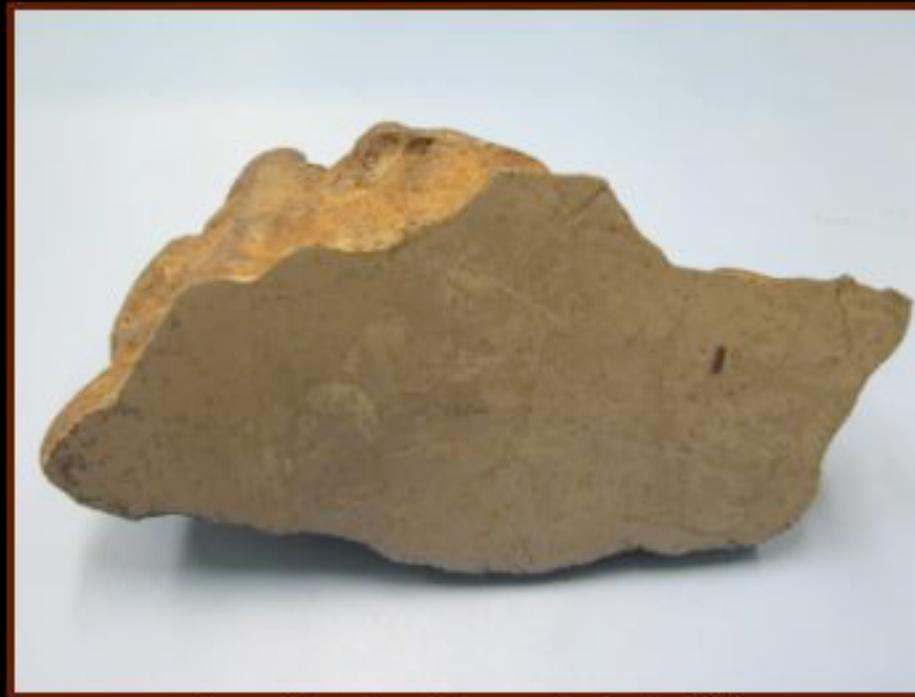
Picture of the cut face of the meteorite . Credit: AMNH

**Engineers tested on the cut face of the meteorite
to measure the wear and tear on the Rock Abrasion Tool.**

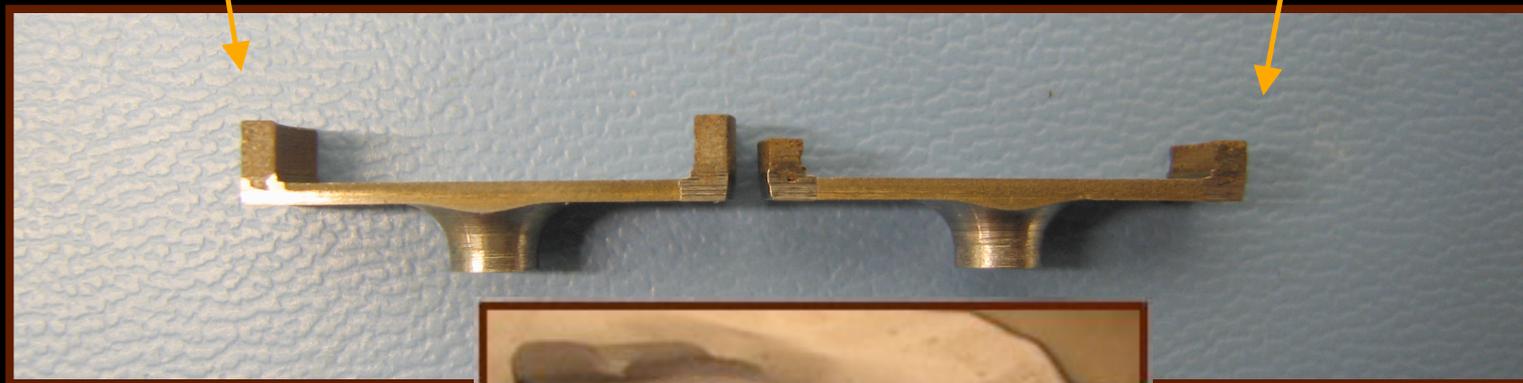
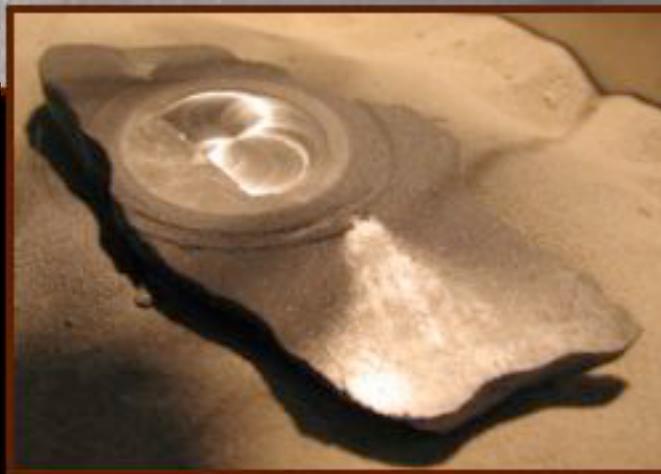
Engineers discovered that the wear and tear on the grinding bit was very high.

Fresh Grinding Bit

Grinding Bit After 2 Hours

*Results, Honeybee Robotics,
January 17, 2005.*

Thus, rover team members like Phil Chu decided not to grind “Heat Shield Rock” in order to save the RAT for many more martian rocks along Opportunity’s continued journey.

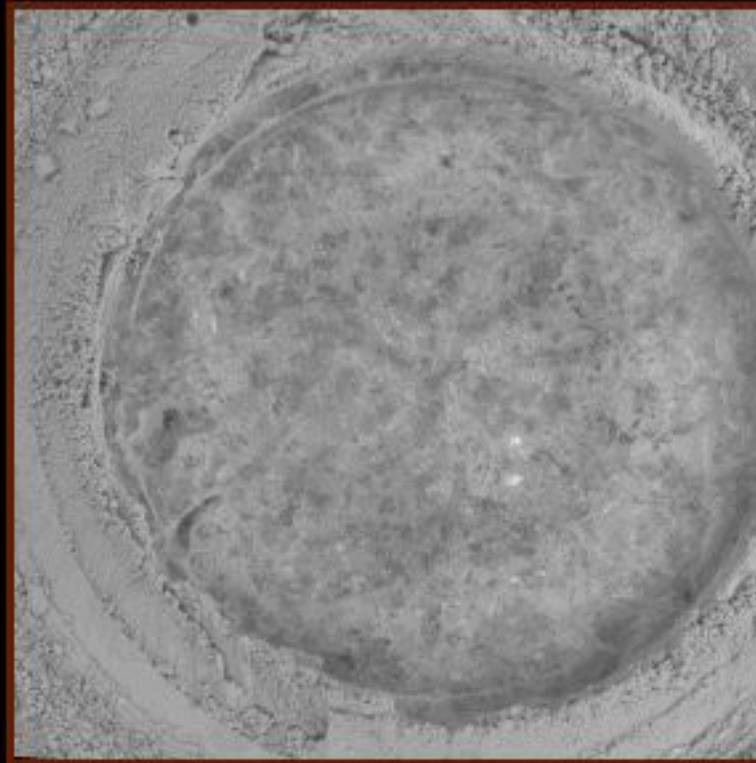
*Microscopic image of target “Bubbles” on “Champagne,” January 3, 2005.
NASA/JPL/Cornell*

*The circular area is about 2 inches
(4.5 centimeters) across.*

The science team discovered that Champagne is rich in phosphorus, and wants to understand how that may relate to the history of water on Mars.

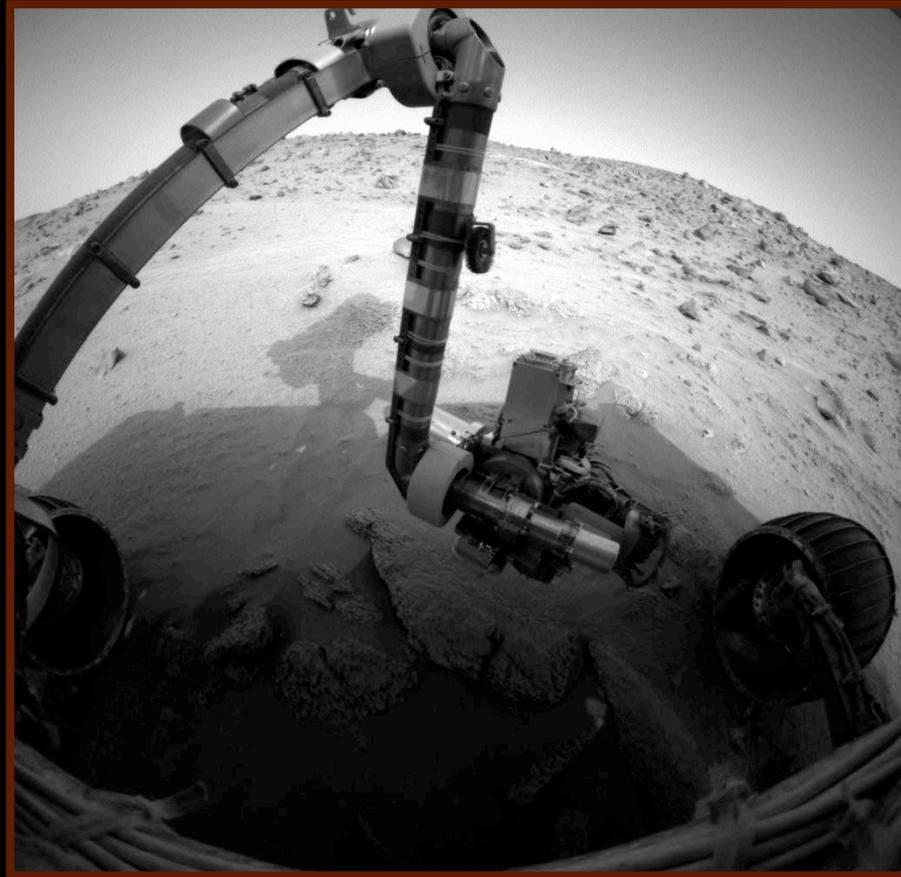
Front-hazard avoidance camera image, January 18, 2005.

Peace was such an unusual rock that the science team decided to study it for over a week. Results are pending.

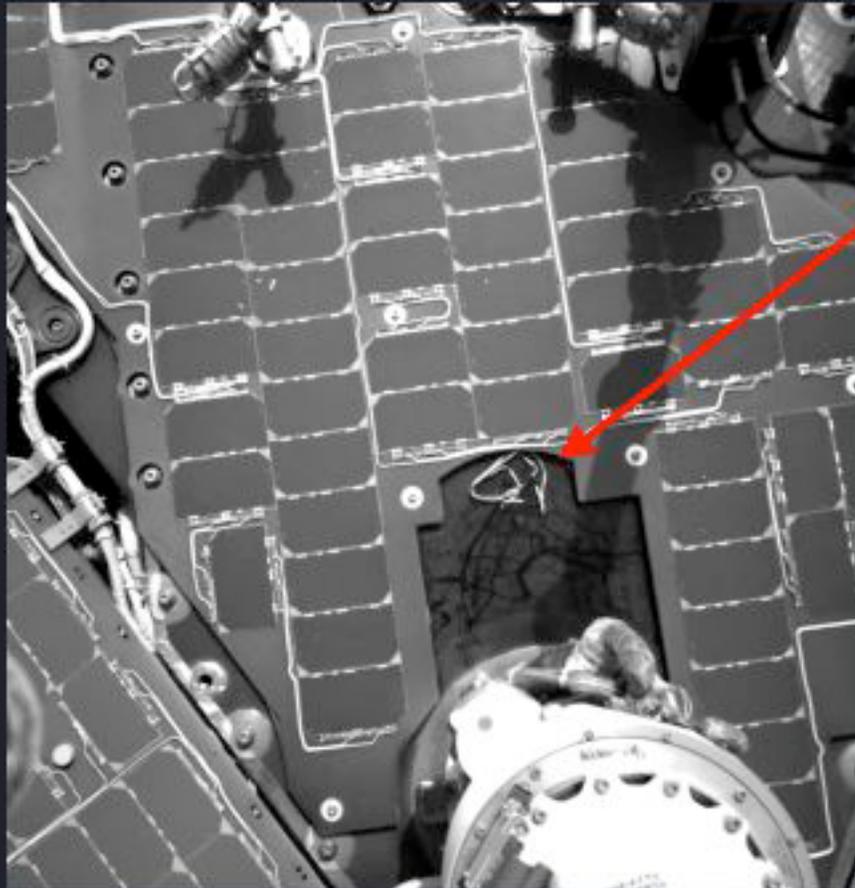
Spirit has braved the martian dust throughout the year, as proven by a cable tie that has left a trail of streaks in a fine layer of dust on the rover deck.

Navigation camera image, January 3, 2005. NASA/JPL

The cable tie, which resembles a wire used to fasten bags around loaves of bread, is one of 1,000 cable ties on the spacecraft.

Engineers speculate the tie sprung loose from some part of the rover during the spacecraft's Entry, Descent, and Landing phase or during the rover's Egress from the lander.

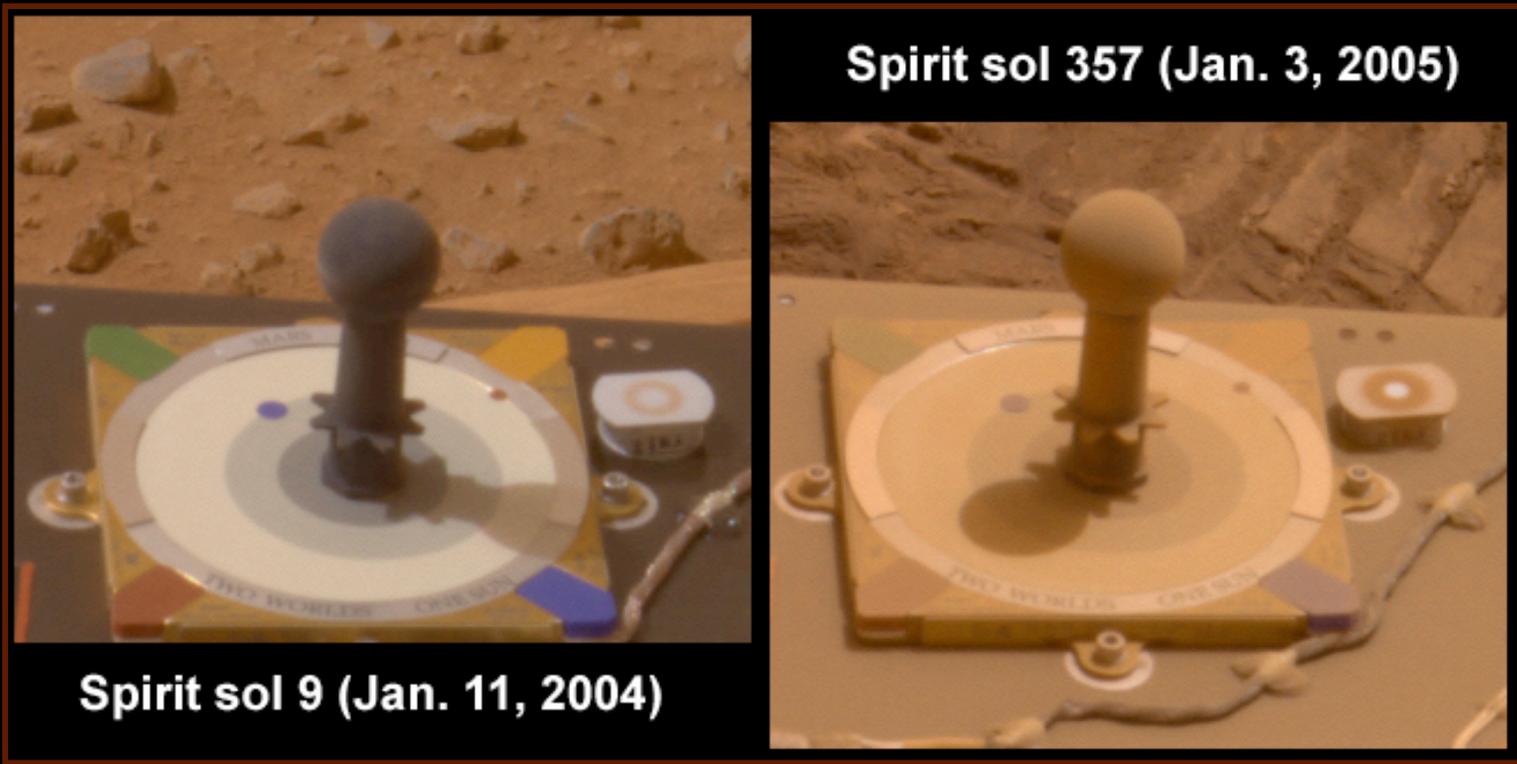
Spirit's calibration target also shows how dust has accumulated on the rovers during the last year.

Panoramic camera images. NASA/JPL/Cornell. The calibration target is used to help scientists color images from Mars correctly.

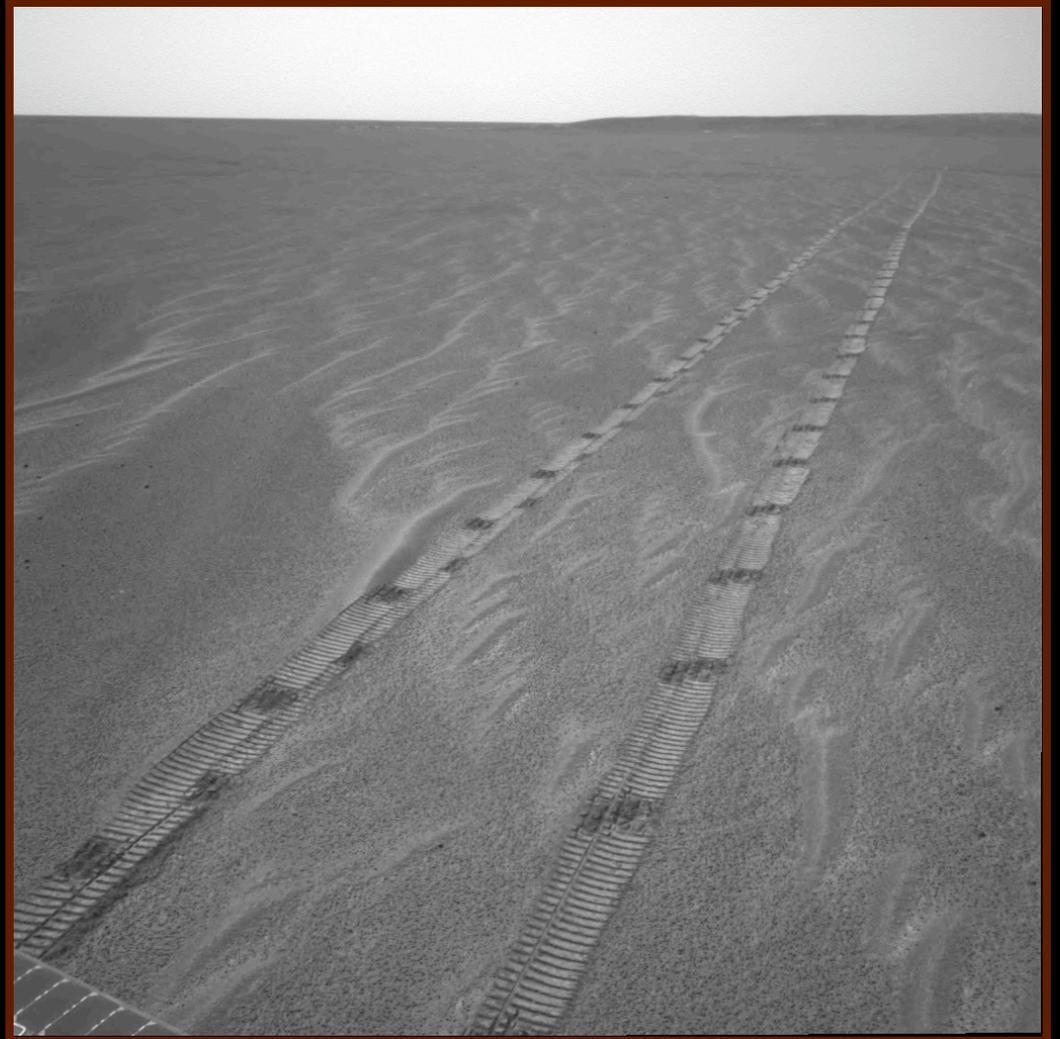
*Opportunity's journey south toward a small crater.
Navigation camera image, January 26, 2005, NASA/JPL*

Opportunity is heading south for a small crater referred to as “Argo.”
